Registration of Observed Icing on Overhead Lines in Iceland

Abstract — This article describes the registration of observed icing on overhead lines in Iceland. The article provides an overview of the data sources, and how they were evaluated, as well as the observation and registration of new events, and how the data was entered into a special database (IceDat) developed for this purpose. The system of location is described along with the main features of the database. IceDat is divided in two: an icing database and a damage database. The number of records in each part in June 2019 is 3926 and 2429, respectively.

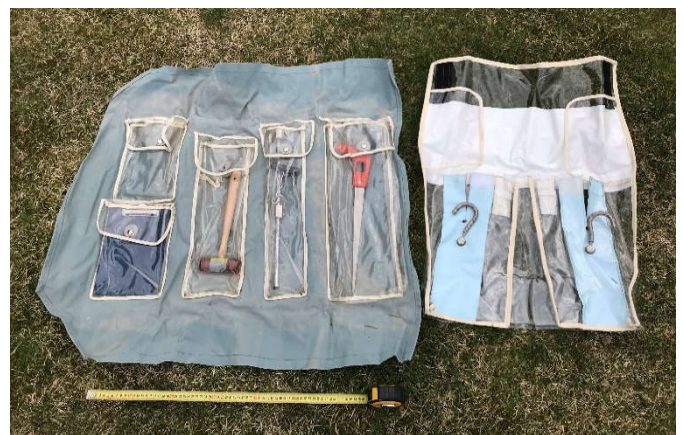
Fig. 2 A kit of simple portable tools for the observation of icing.

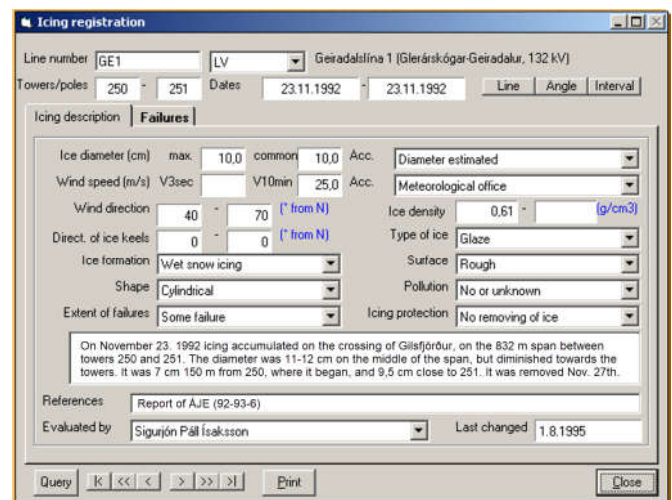
Line number		LV		Geiradalstína 1 (Geirárskógur-Geiradalur, 132 kV)		
Towers/poles	250 - 251	Dates	23.11.1992 - 23.11.1992	Line	Angle	Interval
Icing description						
Failures						
Ice diameter (cm)	max. 10,0	common 10,0	Acc.	Diameter estimated		
Wind speed (m/s)	V3sec	V10min 25,0	Acc.	Meteorological office		
Wind direction	40	70 (° from N)	Ice density	0,61 (g/cm ³)		
Direct. of ice keels	0	0 (° from N)	Type of ice	Glaze		
Ice formation	Wet snow icing		Surface	Rough		
Shape	Cylindrical		Pollution	No or unknown		
Extent of failures	Some failure		Icing protection	No removing of ice		
On November 23, 1992 icing accumulated on the crossing of Gilsfjörður, on the 832 m span between towers 250 and 251. The diameter was 11-12 cm on the middle of the span, but diminished towards the towers. It was 7 cm 150 m from 250, where it began, and 9,5 cm close to 251. It was removed Nov. 27th.						
References	Report of A/E (92-93-6)

Fig. 5 The icing description window. The Gilsfjörður event.

A more accurate description of the icing and its distribution is given in text, and other things which may be necessary or advisable to report. Finally, the sources are listed, the name of the person who brought information into the icing database and the date when it was done (Fig. 5).

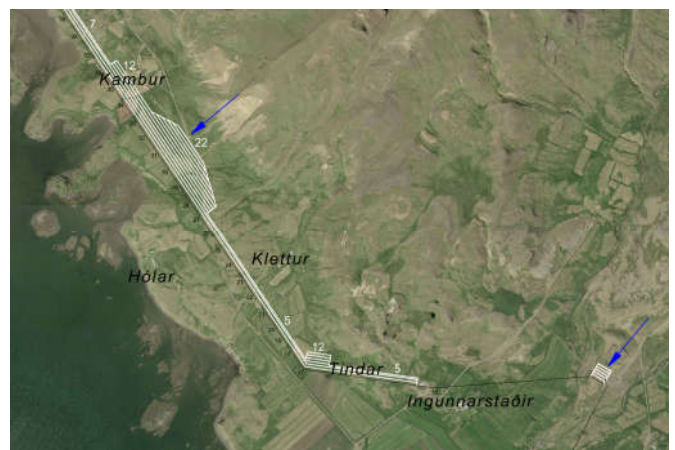
Fig. 6 Wet-snow icing on Mjólkárína 1, West Iceland, 20 February 2014. The icing diameter at each line section is shown.

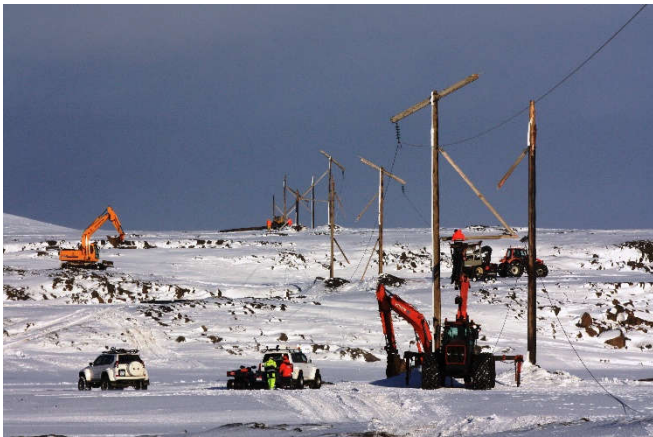
Fig. 7 Catastrophic failure in the north of Iceland, Kópaskerslína 1 (KS1) 10.09.2012.

Fig. 12 Data from a load cell in mast no. 168 on Kópaskerslína 1, 66/132 kV. Event No. 8 is in the Icing Database. It was catastrophic wet snow icing, see Fig. 7 and 8. The other events are not there, but they are in most cases minimal.

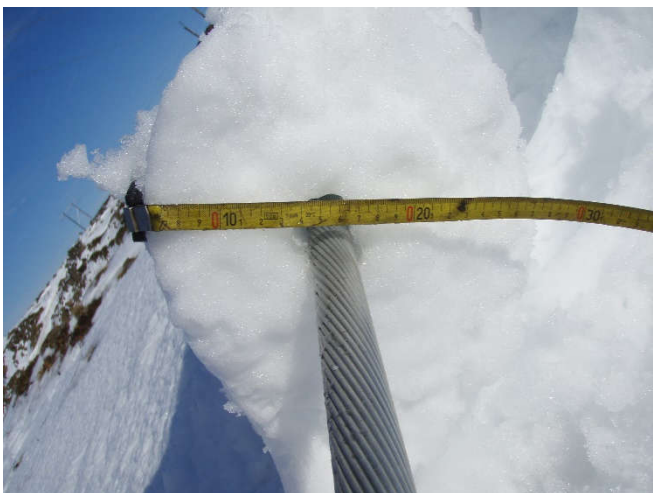
Fig. 8 Extreme midspan-diameter in the same event, 27 cm.

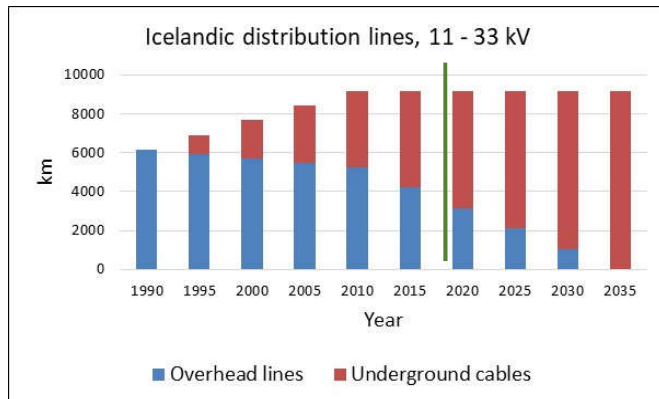
Fig. 10 The Icelandic distribution net, OH-Lines and Cables. Predicted values are on the right side of the vertical line.

The first transmission line of any significance in Iceland was a 45 km 66 kV line from Ljósafoss Power Plant in the Sog River to Reykjavík, built in 1935. After the Second World War, especially after 1954, the construction of a distribution line system around Iceland proceeded rapidly. This work was not finished until ca. 1980. In 1990, the distribution overhead line system was 6166 km long (Fig. 1). Now, the change to underground cables is in progress, and it will probably be completed in 2035 with ca. 9000 km of cables (Fig. 10).

Another field worth discussing is the replacement of overhead distribution lines with underground cables. This is process which began ca. 1993 and will be finished in 2035 (Fig. 10). The urgency of prioritizing the laying of underground cables around Iceland was what really necessitated the construction of the Icing Database. The rapid decrease in broken poles after 1995 shows that it has been very useful, see Fig. 13. A comparable decrease is in the number of reported icing records, see Fig. 14.

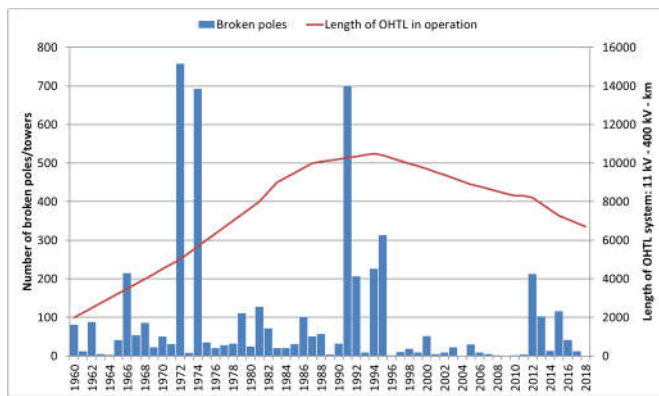
Fig. 13 Number of broken poles due to icing, registered since 1960. Note the fall after 1995; the prioritizing of the underground cables began in 1993. In 2012 and 2013, severe icing weather in the north were comparable to the weather in 1991.

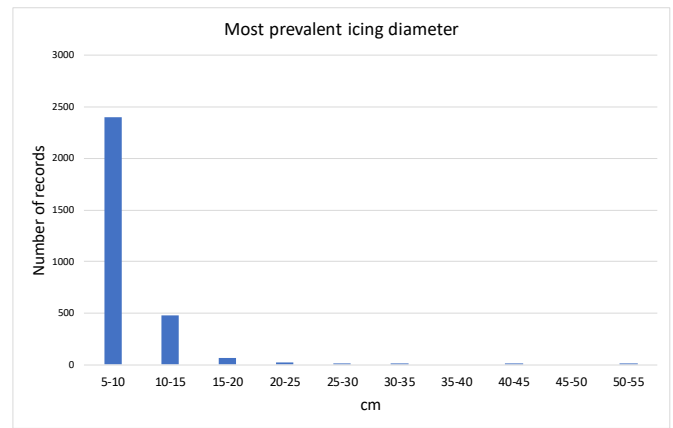
Fig. 15 Most prevalent icing diameter (measured/evaluated), number of records.

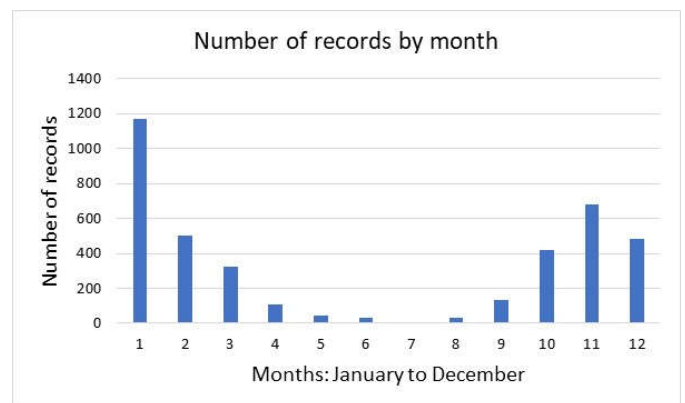
Fig. 16 Distribution of icing records during the year.
